Crystal Peak Log

April 7, 2002 Sunday

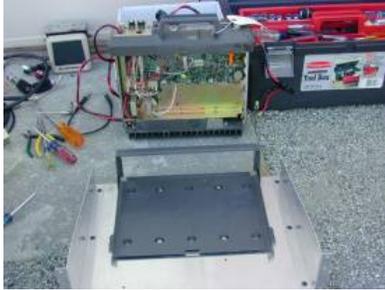
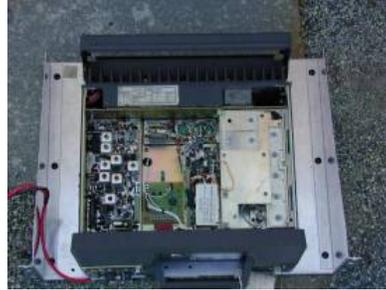
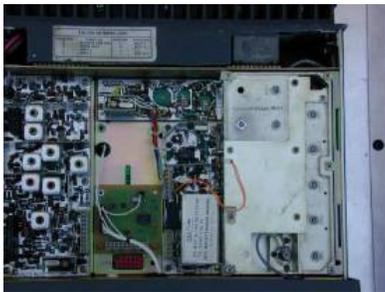
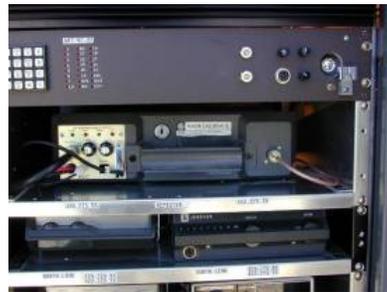
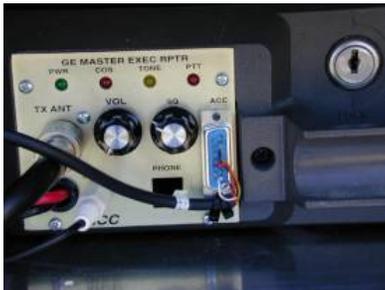
Removed Motorola receiver, Kenwood transceiver (transmitter), fan and barrier strip. Installed GE Mastr radio into the repeater shelf. Easy mounting and easy to remove the radio for service. GE Mastr purchased from Micro Computer Concepts (MCC).

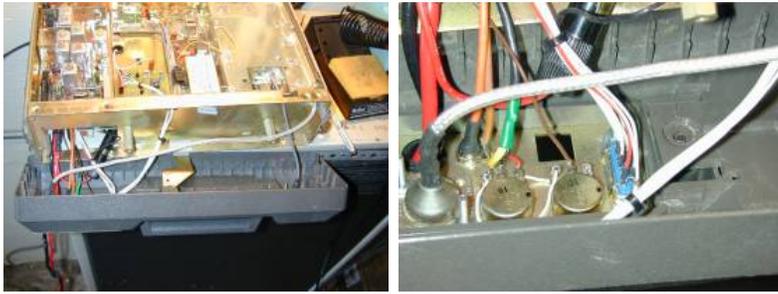
Pulled the Mastr radio from the mount. Tilted the front panel down and found that the wiring to the DB15, pins 10, 11 and 12, was in tact at the connector. Then determined that the other ends of the wires (for discriminator audio and CTCSS TX audio) were simply grounded to the SAS board rather than

connected to the correct connector (J907).

Apparently, the MCC process modifies the Mastr radio this way for “no controller ordered”. Quite frustrating. I phoned Ron at MCC with the radio opened up and got the correct pin numbers for discriminator audio (pin 8) and CTCSS TX audio in (pin 6). Tested for continuity from the DB15 pins 10 and 11, and connected the wires to the SAS board connector (J907).
