Crystal Peak Log

April 7, 2002 Sunday

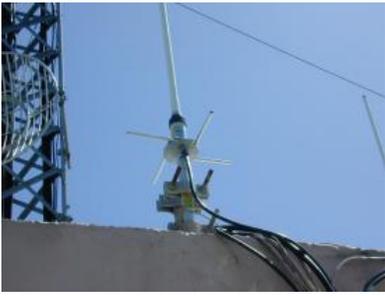
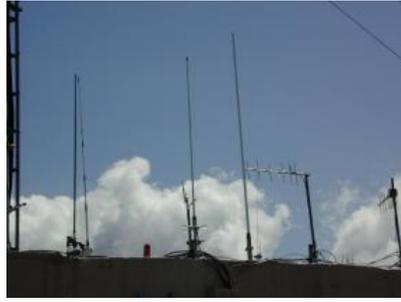
Next tested for SWR on the (interim) antenna. 60 w forward and 50 w reflected! Put a dummy load on the end of the coax (1/2” hardline) and got the same reading. Found an old run of Belden 9913 coax with N connectors and replaced the hardline. SWR was now about 10 watts reflected with about 55 watts forward. The G6-440 must just be tired (15 year old antenna). Installed the radials (they were missing) on the G6-440. Heard W1AIX at his office (handy talky into a mobile antenna on his bookcase). He was good copy. Then heard W6STR mobile in Monterey. Some picket fencing but also good copy.
